Proposal for Road and Port Improvement

- Meeting between JCCIC & GoTN on 19th July 2016 -

Roads and Ports Infrastructure Committee

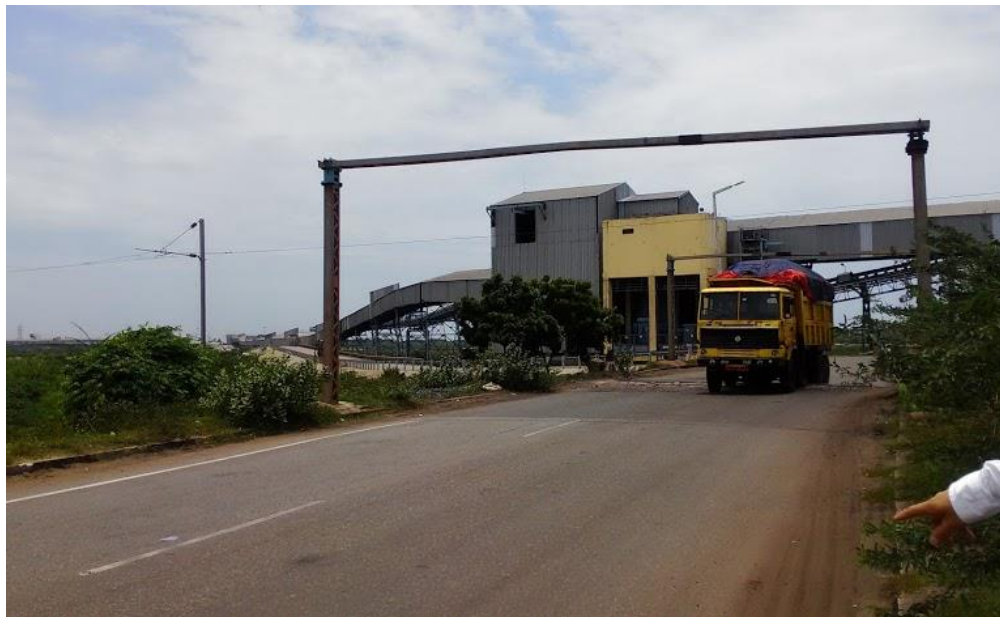
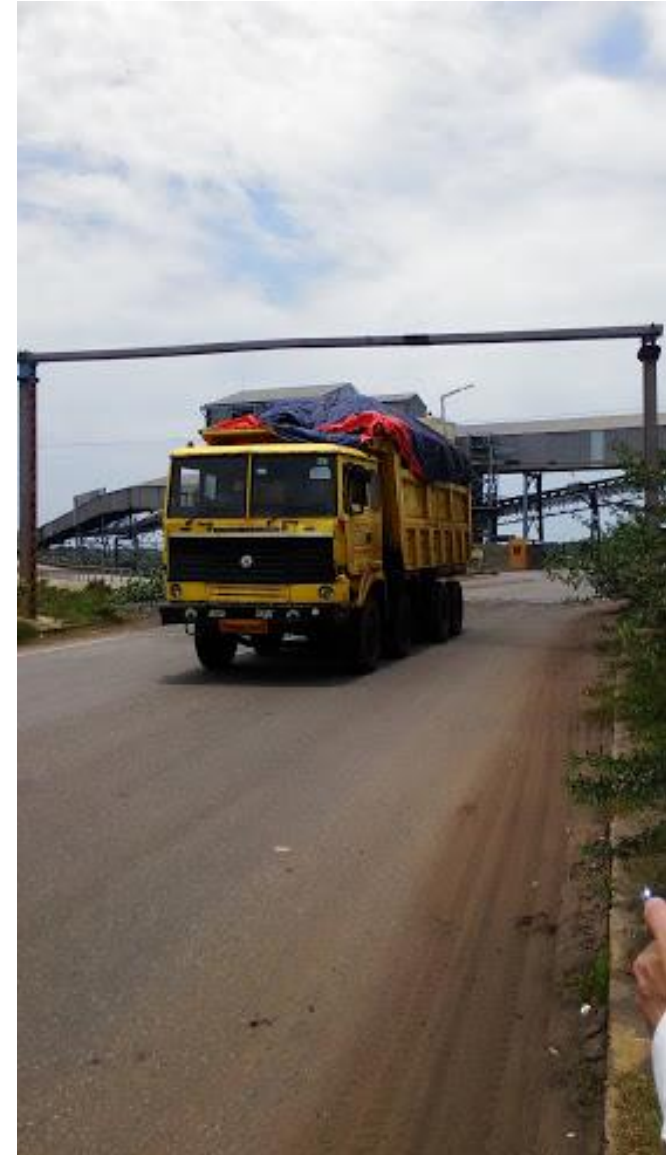
2-1) Raise the overhead wiring and the railway barricade at the crossing in front of Kamarajar Port's Gate.

- The overhead wiring and the railway barricade at the crossing in front of Kamarajar Port's Gate is an obstacle for Japanese companies to carry the cargos. They have been forced to pass the crossing after dismantling, in case they carry the oversize cargo.
- Request to consider raising both overhead wiring and the railway barricade at the crossing or introducing the diesel freight train which requires no overhead wiring instead of the existing one.

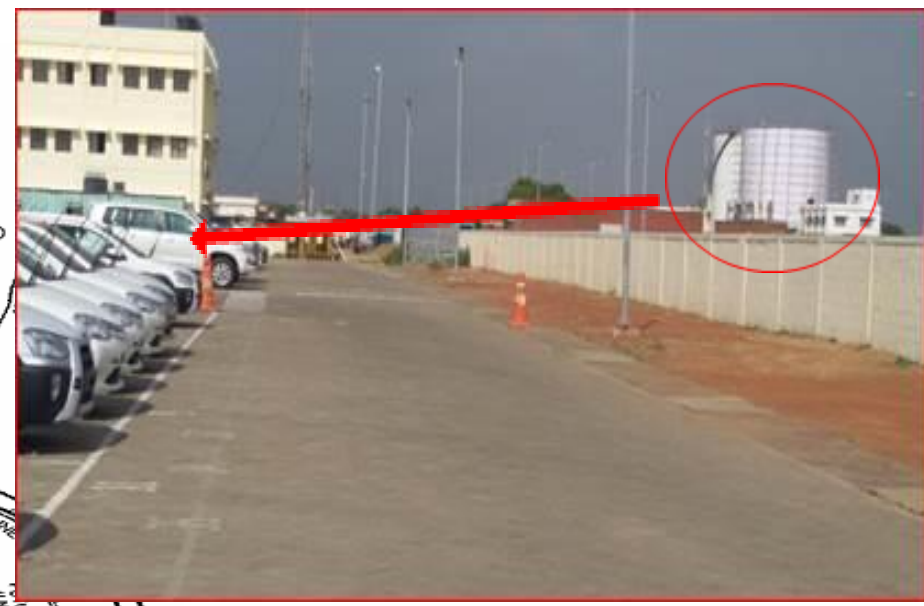
2-2) Paint Contamination on export cars at storage area from ETTPL(Ennore Tank Terminal) in Kamarajar Port

- Paint contamination on around 8,000 units of export cars in the storage area occurred on Friday 11th March 2016. The source of this paint contamination was due to spray painting work carried out by ETTPL during night time.
- This paint contamination brought delay of shipment and additional expenses due to washing and removal work to four automakers.
- **Request Kamarajar port to make regulation to avoid recurrence of the same kind of contamination and ask all the port users to follow it.**

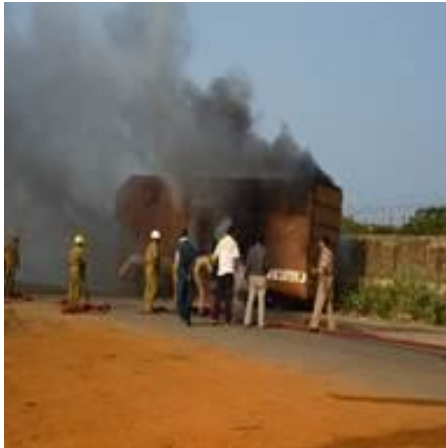
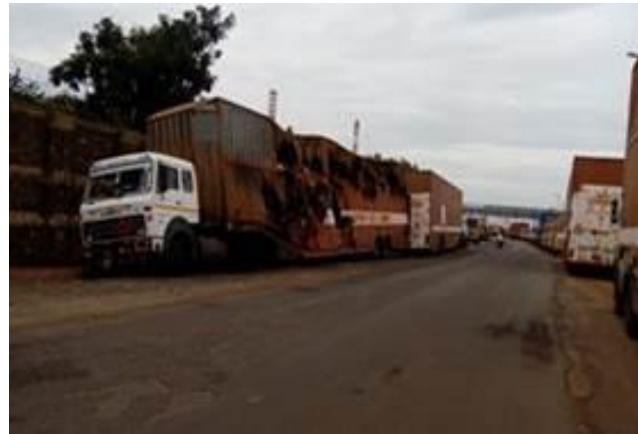
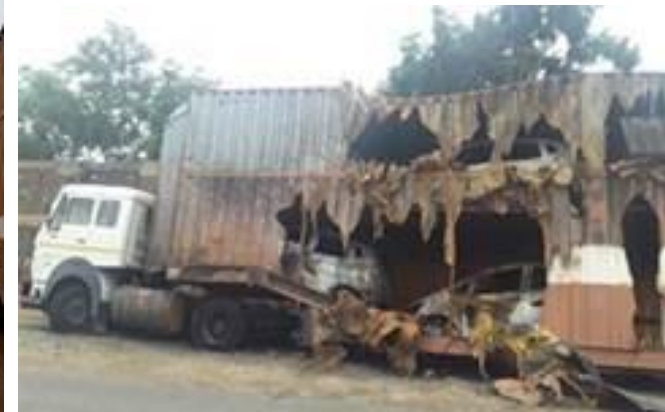
2-3) Heavy damage by touching the high tension voltage cable outside Kamarajar Port

- The fire accident happened outside port compound wall near pass section of Kamarajar Port on 25th June 2016. While the trailer parks close to the wall which is nearer to Gate No.1 for making port entry pass, the trailer roof touched with high tension voltage cable which was lying low, immediately the trailer caught fire, driver felt electric shock and jumped out of the trailer. Within few minutes, all 8 Japanese export cars caught fire and were completely damaged along with the trailer. The same kind of fire accident has happened twice! (28th Jan. 2013 and 9th June 2016)
- Request to raise this high tension voltage cable or lay it underground.
- Need to place some signboard or height indication so as to warn the drivers as temporary measures ASAP.
